**Justification:
Safety Instruction
(Maintenance)**

**Private Owner
Circular Letter
632 Issue I**

**TF25 Bogie Radial
Arm Axlebox
Bushes**

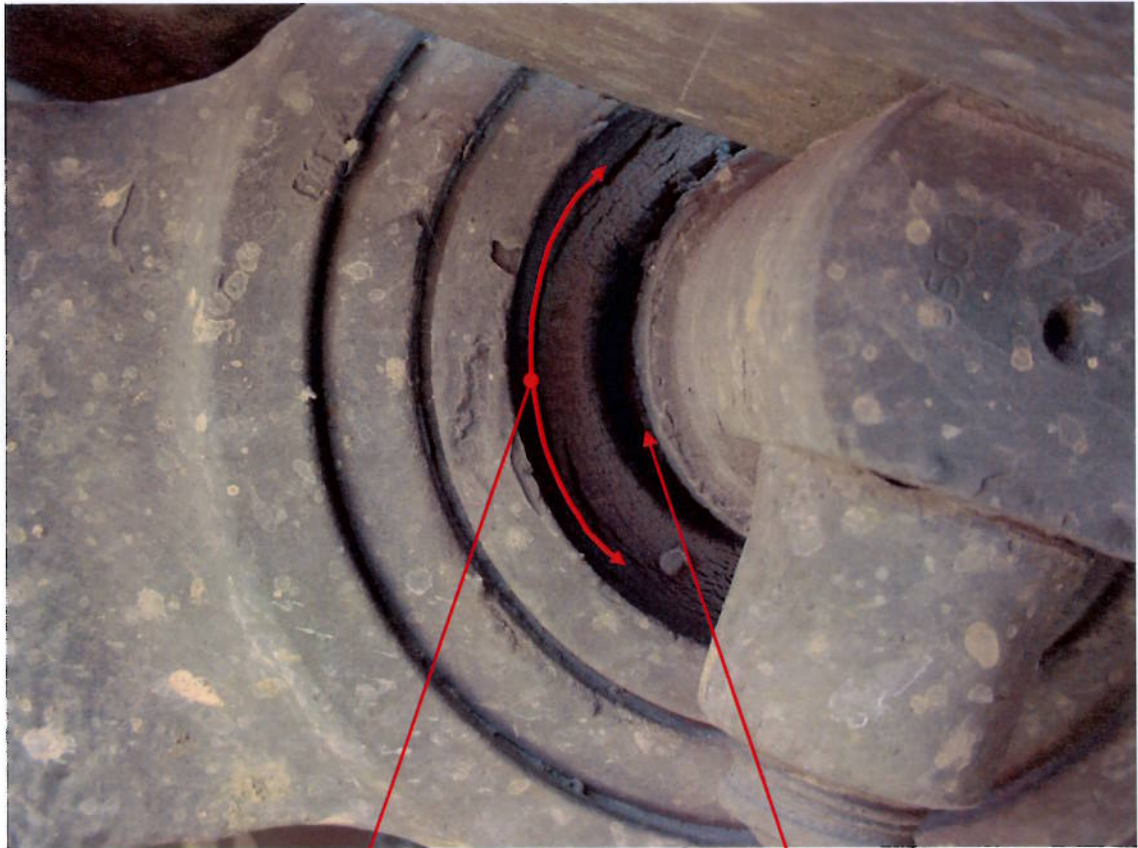
Deterioration of the TF25 bogie radial arm axlebox bushes manifests itself in the form of cracks, splits in the rubber or de-bonding of the rubber from the metal components. POCL 632, Issue 1 provides guidance to staff when inspecting the bushes at planned maintenance events and information as to when they require replacing with new.

Cracks and splits (length measured circumferentially)

Rubber de-bonding from steel trunnion

Figure 1 Cracks, splits and de-bonding of rubber bush

At PPM and VIBT visually inspect radial arm axlebox bushes (see Figure 1). Renew any bush that has a crack, split or de-bonding longer than 100mm circumferentially and is deeper than 20mm*.

*Note: The 20mm is the total depth. For example it may be 20mm deep when measured on just one side. Alternatively it may have additive 'side to side' values of 10mm and 10mm or 5mm and 15mm to give a total depth of 20mm.

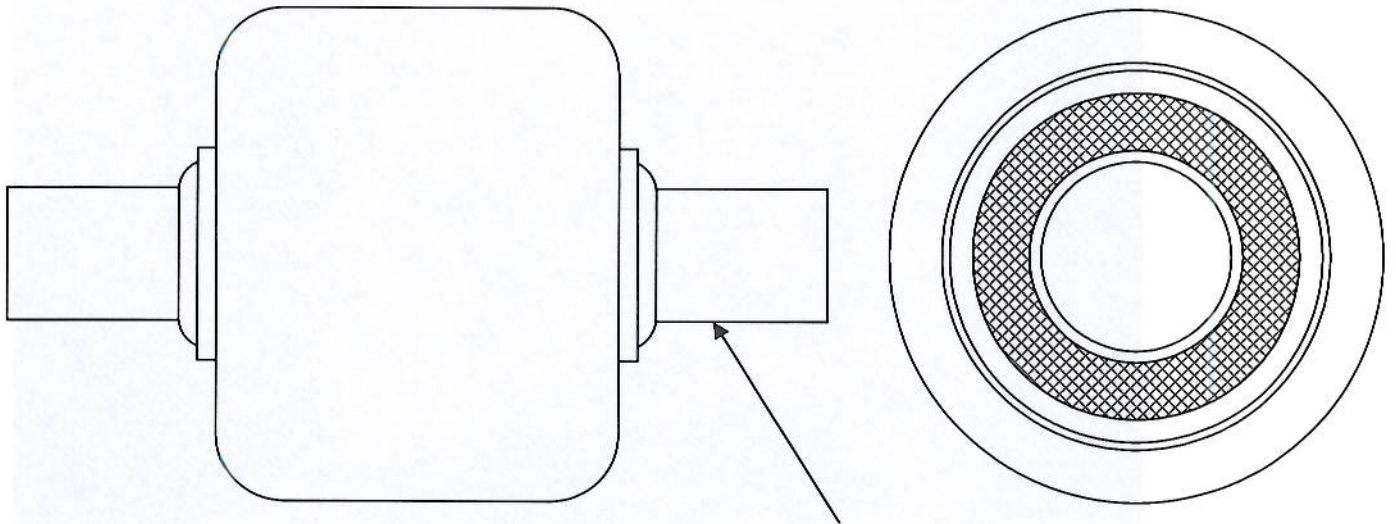
Figure 2 Original (G1) Bush – Plain Trunnion

The manufacturer's advice regarding the original (G1) bushes (see Figure 2) is that they will not last 10 years. Their recommendation is therefore that all G1 bushes shall be replaced with new, second generation (G2) within 10 years or 500,000 miles in service.

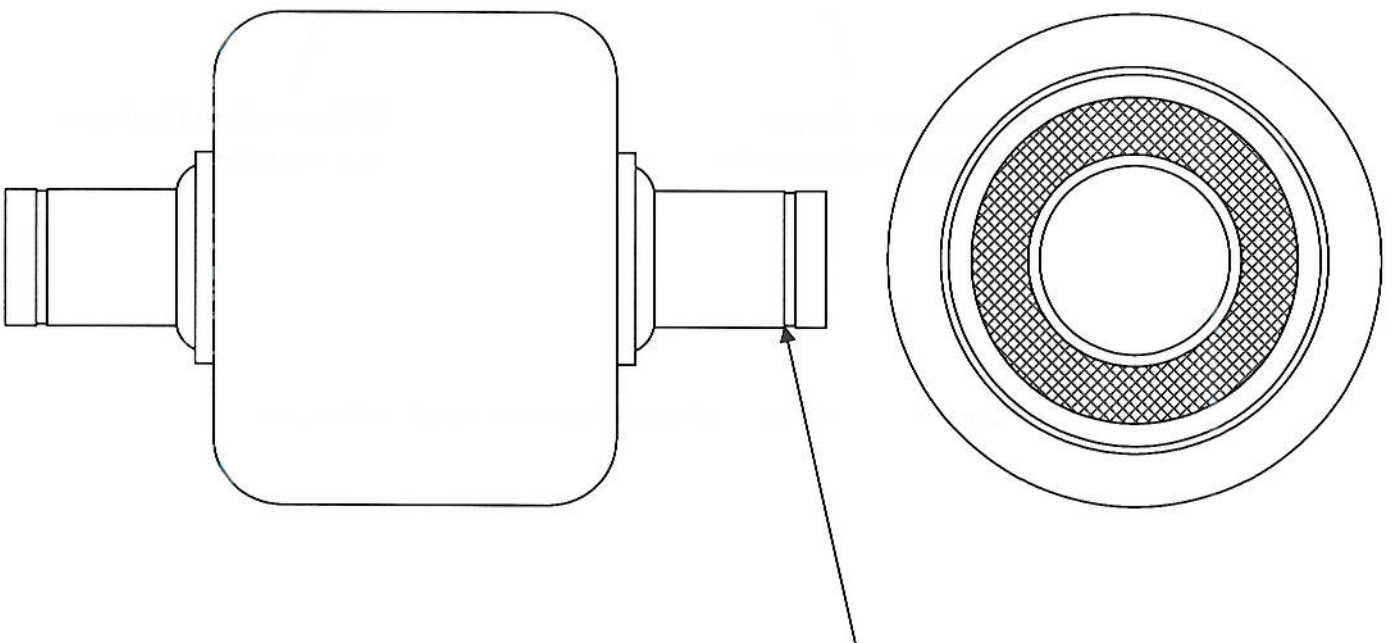
Figure 3 Second Generation (G2) Bush – Groove in Trunnion
Ferrabyrne Drawing No. TBB 116 002 000

The manufacturer's advice regarding the second generation (G2) bush, identified by grooves in the trunnions (see Figure 3) is that they will last at least 10 years or 500,000 miles, however, testing of examples is required to confirm the actual life. Therefore, until advice to the contrary is received all G2 bushes shall also be renewed at 10 years or 500,000 miles in service.
