Private Owner Circular Letter 649 Issue I

VNHI Bogie Frame
Fracture

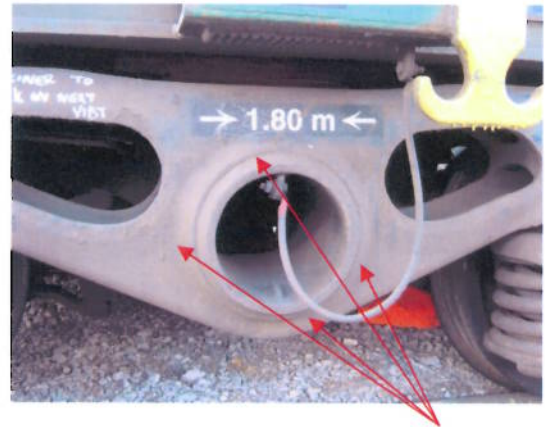
A side elevation of a VNHI bogie is shown in Figure 1 and the area to examine for fractures is shown in Figure 2. Figures 3 and 4 show the major fracture found on the Freightliner Group bogie.

Fig 2 Areas to check for fractures

At all examinations and maintenance events carry out a visual check of the bogie frame for any signs of fracturing in the relevant areas. If any bogie frames are found to exhibit fractures, the wagon shall be red carded pending removal of the bogie, which shall then be quarantined.

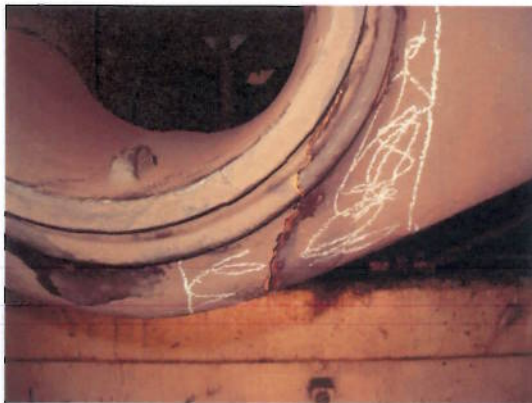
POCL 649, Issue 1 requires Owners of VNHI bogies to carry out special checks for bogie frame fractures. This results from the issue of NIR 2515 (Initial), detailing the discovery of a major fracture on a VNHI bogie fitted to a Freightliner Group FTA wagon.

Fig 3 Fracture found - outside view

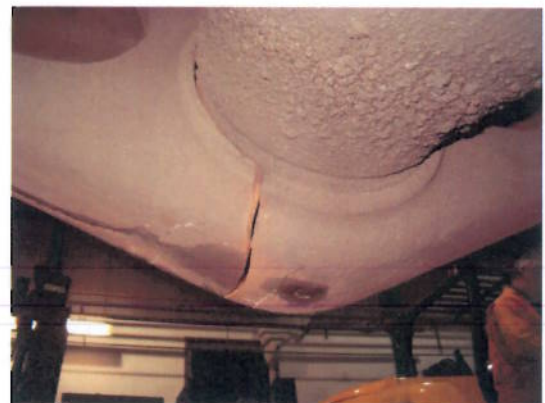
Fig 4 Fracture found - inside view
