Private Owner Circular Letter 653 Issue 1

Distorted Axle Bearing Abutment Rings

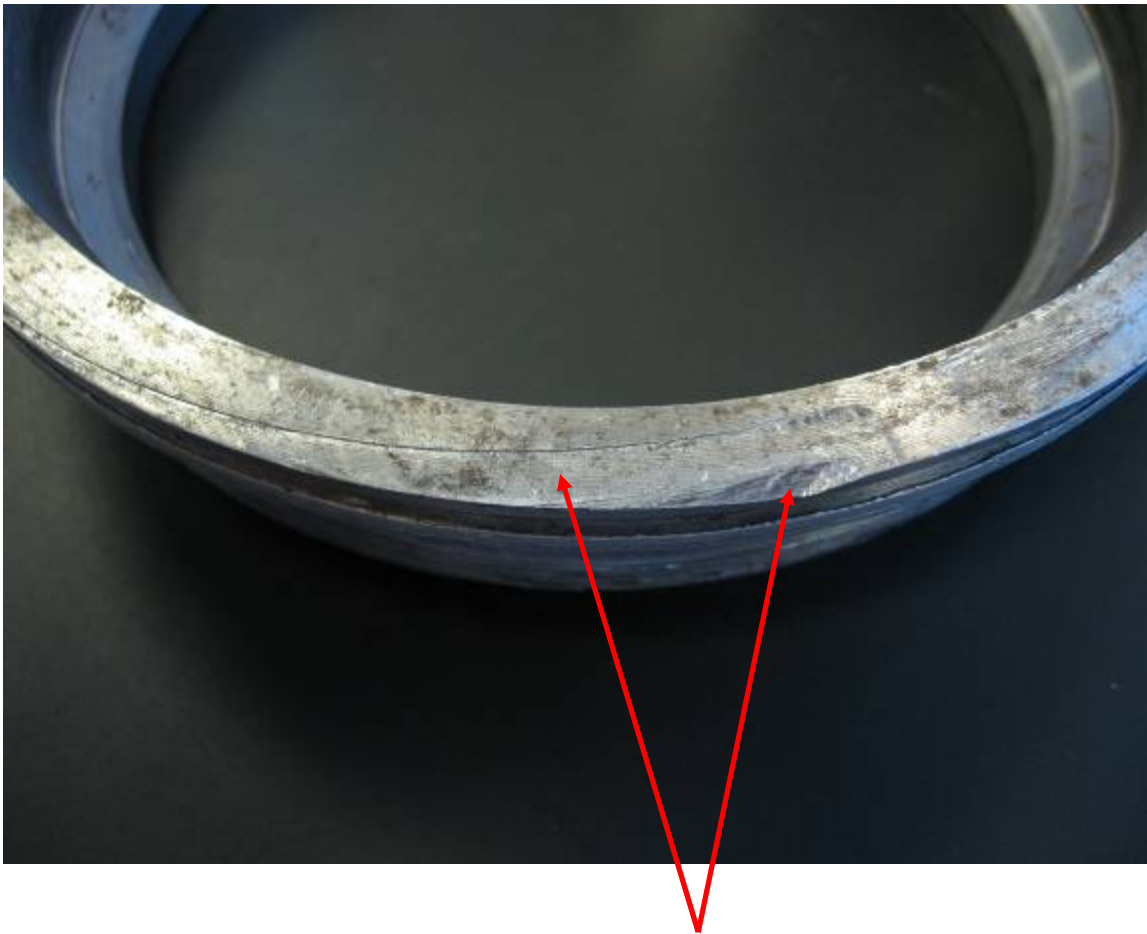
NIR 2614 (Complete) identified that severe damage had occurred to the labyrinth seal surfaces of the abutment rings of SKF Ø150mm spherical roller axle bearings and scoring on at least one axle. The cause of this damage was attributed to the axle bearings being removed in an inappropriate manner, which caused distortion to the axle bearing abutment rings. When re-assembled onto the wheelsets the distorted axle bearing abutment rings in turn caused the severe damage to the labyrinth seal surfaces.

Figure 1 Damage caused by being removed in an inappropriate manner

If any of the above are found the wagon shall be immediately withdrawn from service for rectification.

Axle bearings shall only be removed in accordance with the manufacturer's instructions and using the purpose designed equipment prescribed. In the case of the SKF Ø150mm spherical roller axle bearings (and similar) this shall be by using a full face adaptor (see Figure 3) rather than the more usual 'Horsehoe' half adaptor (see Figure 4).

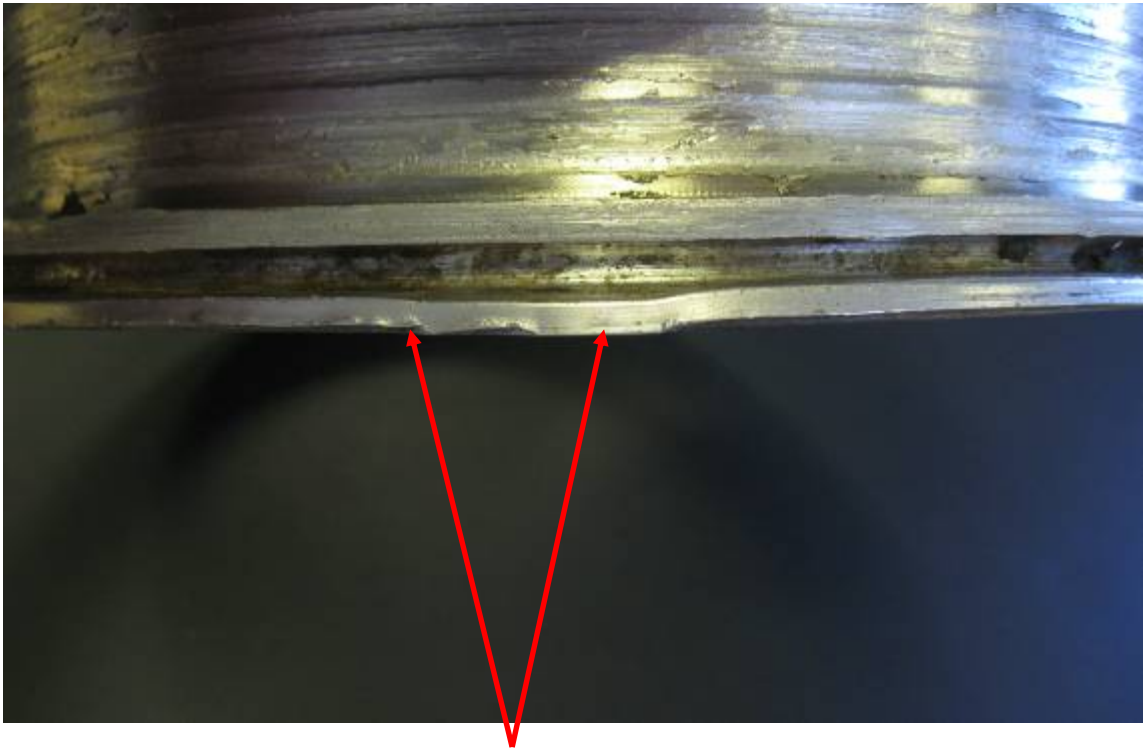
Figure 2 Damage caused by being removed in an inappropriate manner
