**Private Owner
Circular Letter
658 Issue 2**

Cracks in
Gloucester Three-
Piece Bogie
Bolsters (Disc
Braked Wagons
Only)

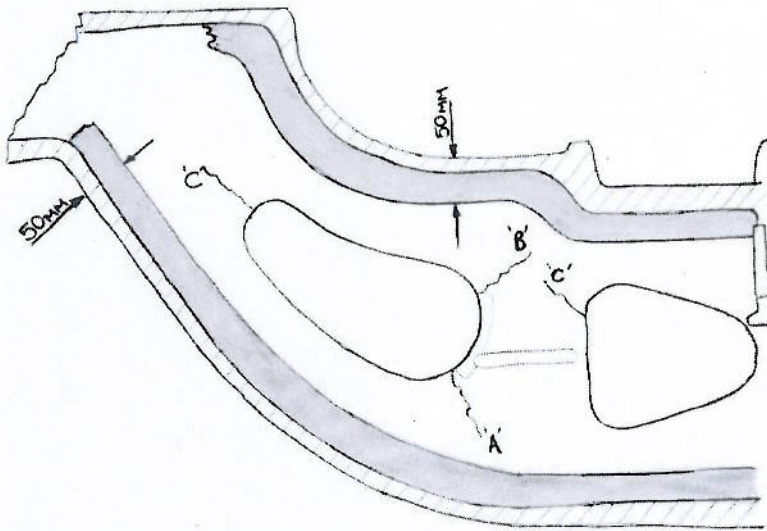
Fig. 1 – View of Internal Bolster Web

The fractures in the internal bolster webs around the lightening holes are a known historic problem and were first identified in the early 1990's. It is thought that these fractures originally initiated from casting defects in the poor quality castings and that these fractures have not propagated any further since this time.

Once the area/fractures have been thoroughly cleaned inspect the bogie bolster webs through the main bolster lightening holes and ensure that if any fractures are present that they **DO NOT** extend into the shaded area of the web as shown in Fig. 1.

Note; 'A', 'B', 'C' & 'D' show typical locations of fractures.

If any fractures **DO** extend into the shaded area shown in Fig.1, then the bogie shall be removed from service immediately and the Senior PWRA Engineer notified.

If the fractures **DO NOT** extend into the shaded area shown in Fig.1, then mark the end/tip of the fracture using a WHITE paint pen, care should be taken to ensure that only the end/tip of the fracture is marked with a spot of paint no larger than 5mm (see Photograph 2).

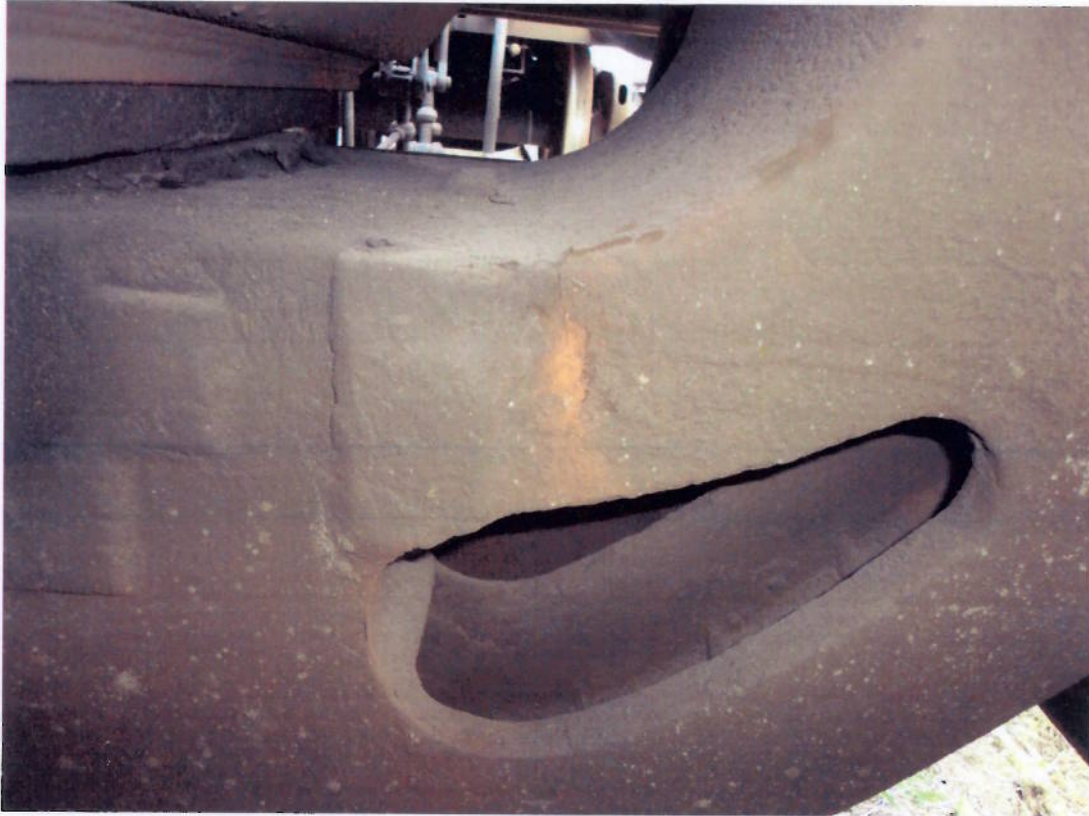
Photograph 1 – Fracture on Outer Surface of Bogie Bolster

Examine the bogie bolster for fracture on the outer surface of the bolster below the sidebearer and above the 'lightening hole' (see Photograph 1). If found, remove bogie from service immediately and report the finding to the Senior PWRA Engineer.
