**POCL 660**

Private Owner Circular Letter 660 Issue 1

Service Inspection of Parabolic Springs

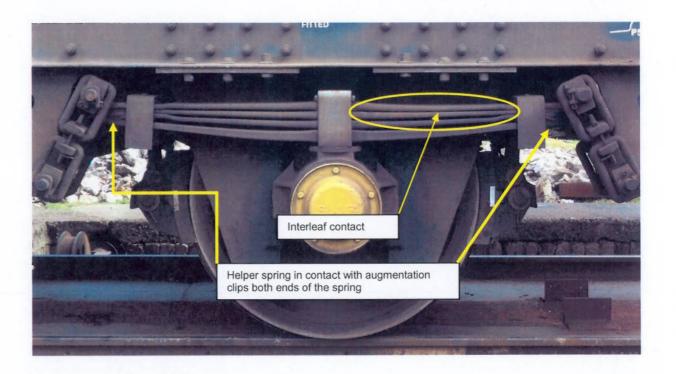
Fig 1
This vehicle was in the tare condition when these defects were observed immediately prior to maintenance.

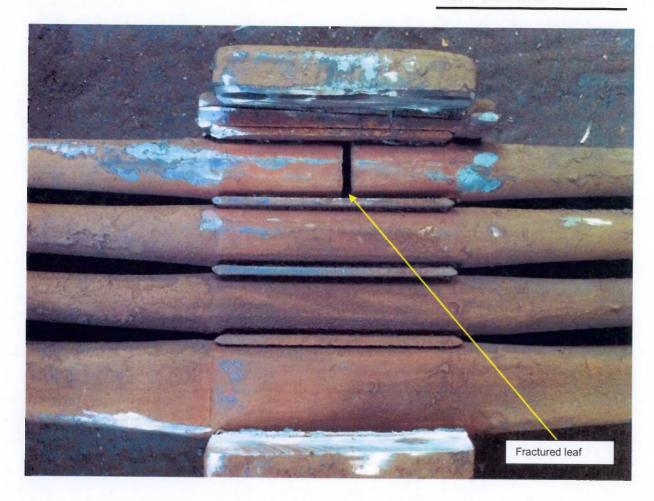
Fig 2 When the buckle was removed from the vehicle as noted in Fig 1 above the top leaf was found fractured
