**Private Owner
Circular Letter
661 Issue 2**

Inspection of
Threaded Eye
Bolts on Bottom
Door Mechanism

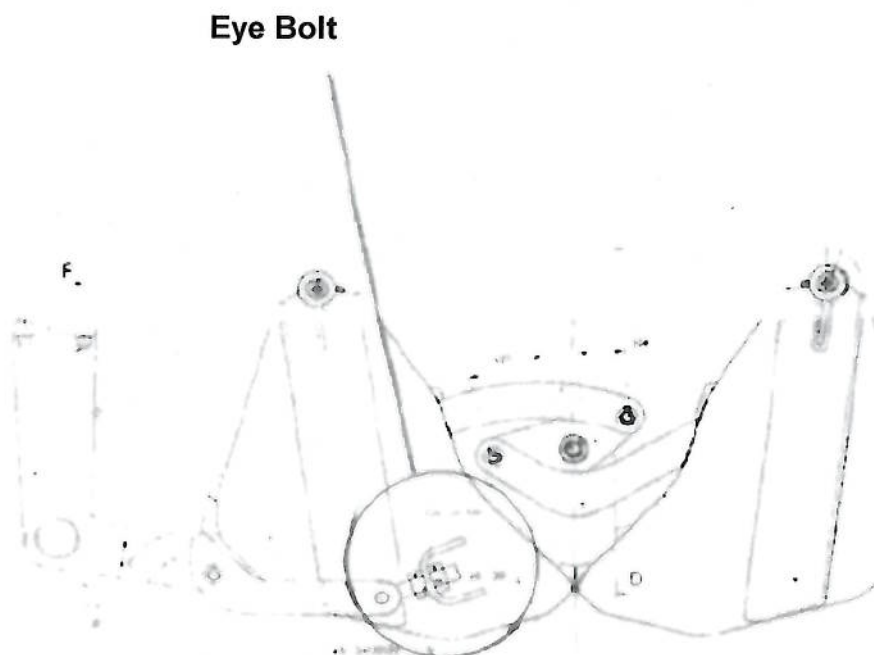
Figure 1 – Location of eye bolt on the bottom door mechanism

NIR 2849 (Initial) identified that the threaded eye bolts on the bottom door mechanism of some HYA type wagons had been found fractured, which in turn loosened the door closure equipment. It is thought that some IIA type wagons are also affected, however, this could be extended to other vehicles with similar discharge arrangements. Further information has been obtained and this indicates that the 26mm (nominal) diameter eye bolts as fitted to IRS (Trinity) designed wagons are the principal area of concern.

- a). Owners should assess their vehicle fleet and advise the Senior PWRA Engineer immediately if any of their wagons are equipped with such eyebolts and bottom discharge arrangements (see Figure 1, 3, 4 & 5) as similar vehicles could be affected.

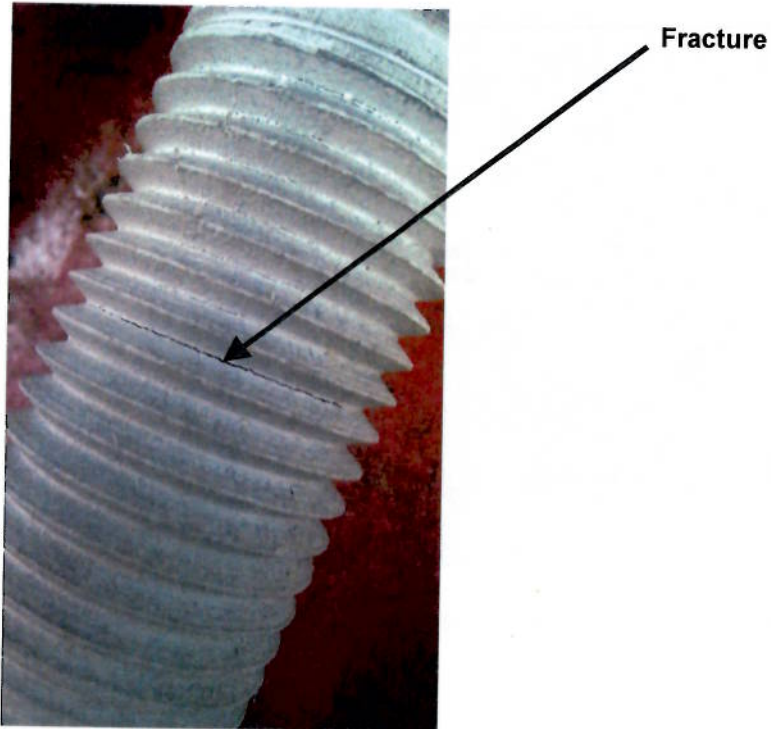
- b). At the next maintenance event, check for incorrectly set door gaps. It is suspected that an incorrect door set up can lead to flexing and deformation of the eye bolt resulting in its cracking and failure. Where there is not a gap, readjust the door gap to ensure a small clearance within the requirements as set out in the wagon's maintenance plan and undertake the following check.

Note: Due to the location of the cracks on the thread, it can be difficult to see any cracks and when using NDT, if a crack is concealed just under the nut it can be missed.
 - ii). Replace any fractured (see Figure 2), deformed or suspect eye bolts with new items.
- c). Advise the Senior PWRA Engineer of details of all fractured, deformed or suspect eye bolts that are found. (This should include the details of when fitted to the vehicle, details of the supplier and the approximate date supplied).

Figure 2 - Fractured eye bolt – this is an example of the damage in early stages on a cleaned up example- some have completely sheared off.

- i). Carry out initially a visual check of the eye bolts: this will involve cleaning all product and debris from the area around the threaded portion and examining it closely for any deformation or cracks. It is believed that the crack propagation is on the bottom side of the eyebolt so it will be necessary to access the vehicle from underneath. If required, confirmation that the eye bolt is crack free can be undertaken by an appropriate NDT method.

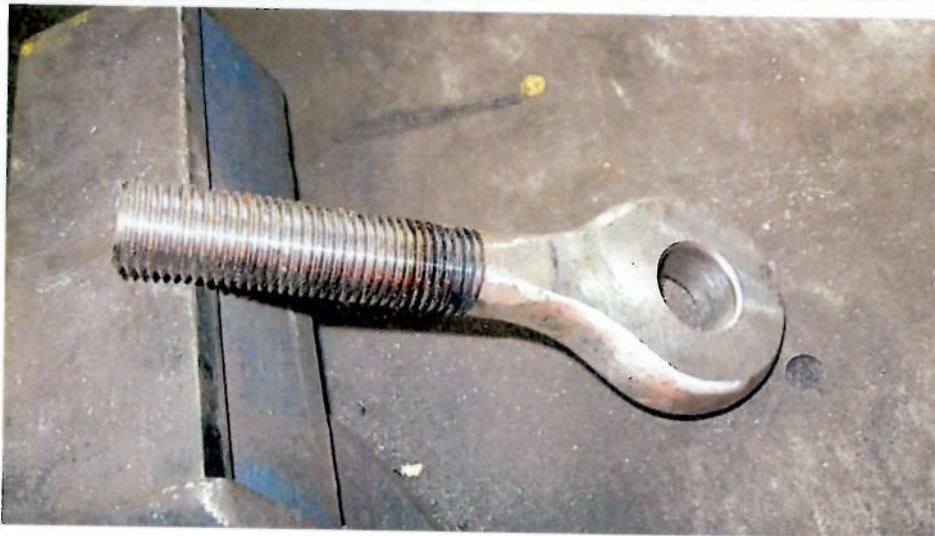
Figure 3 – example of a new eyebolt

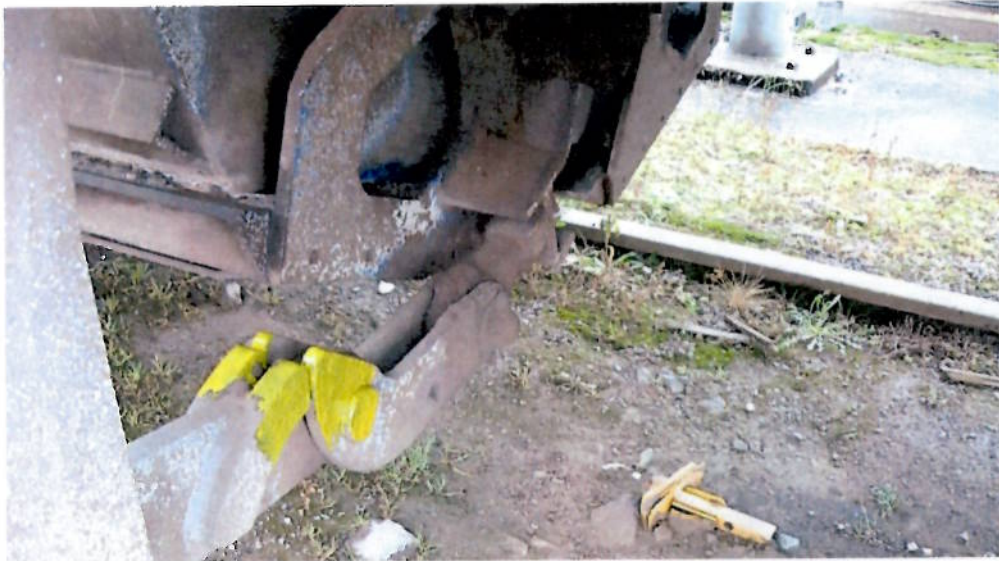
Figure 4 – example of an eyebolt in situ.

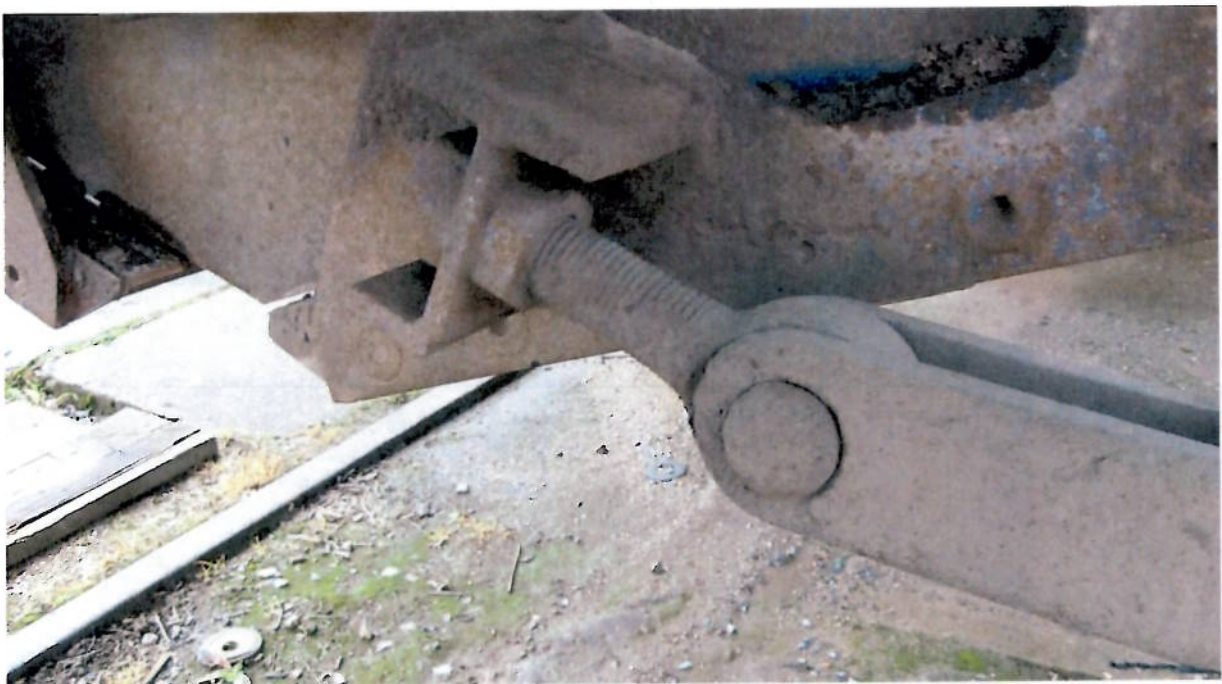
Figure 5 – close up of detail
