Private Owner Circular Letter 663 Issue- Ia

Screw coupling failure.

POCL 663

POCL 663, Issue 1a, has been produced as a result of NIR 2883 received indicating that some vehicles may be fitted with an incorrectly rated screw coupling. The manufacturers X-Press Spares Ltd & Co. KG Hovesaatstr.6 48432 Rheine-Germany; believe that the screw coupling 850kN has been sold into the UK to many customers as a replacement for the C1-A2-9000275 since 2007.

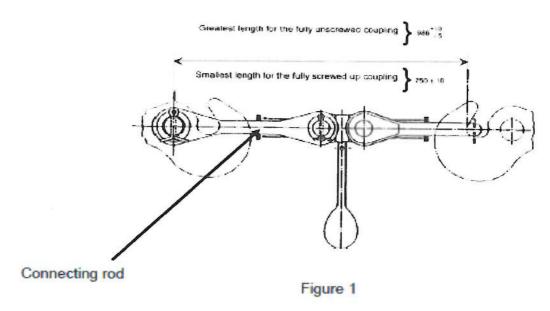
Figure 2

Screw Coupling

Correct 52-55 mm

Incorrect 35-42mm

Inspect the screw coupling to identify if it is the correct type. The most effective way to do this is to measure the depth of section at the centre of the connecting rod. See figs 1, 2, & 3.

INCORRECT COUPLING	CORRECT COUPLING	
Rating 34.5 tonne	Rating 56 tonne	
Drawing B1-C0-9029821 item 06 to UIC 520 (see Appendices A to C)	Drawing B1-C0-9029821 item 05 or C1-A2-9000275 (see Appendices A to C)	
Connecting Rod size 35 to 42mm (see figure 3)	Connecting Rod size 52 to 55mm (see figure 3)	
Either no stamping marks or as per example photographs shown in Appendix D	May be stamped BR or 122T

2. Any screw couplings found to be the incorrect type must be renewed as a complete assembly. Note: the incorrect coupling may be of lower grade steel than the correct version therefore if replacement is required then the entire assembly must be replaced.

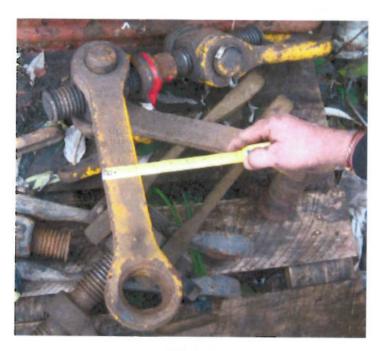
Figure 3

Connecting Rod Dimension to Check (Correct version shown)

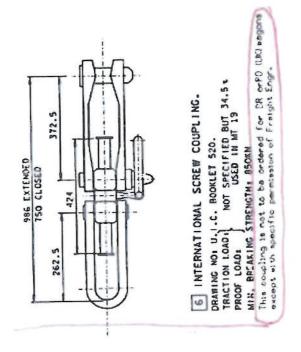
## Appendix A- extract from drawing B1-C0-9029821

DRAWING NO. CI-AZ-9000275 GPR COUPLING.
CRAWING NO. CI-AZ-9000275 GPR CAI NO. 73.7290
(B.R.DESIGN) SUPERSEDES R.C.H.2827
TRACTION LOAD: 56 t
PROOF LOAD: 71 t

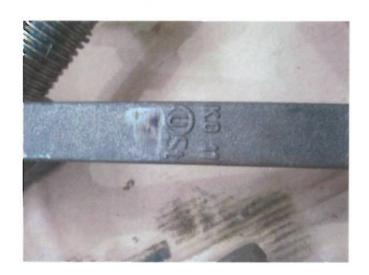
Appendix D Example photographs of incorrect screw coupling
