Private Owner Circular Letter 649 Issue I

VNHI Bogie Frame
Fracture

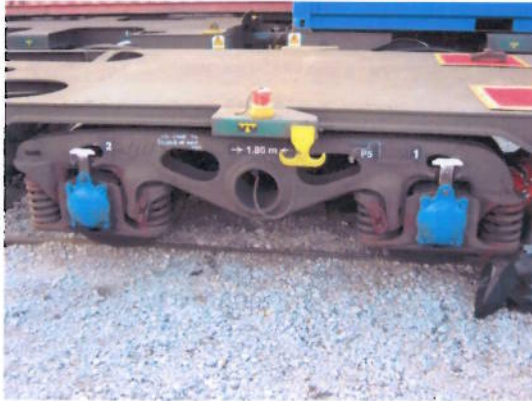
Fig 1 VNHI side elevation

A side elevation of a VNHI bogie is shown in Figure 1 and the area to examine for fractures is shown in Figure 2. Figures 3 and 4 show the major fracture found on the Freightliner Group bogie.

At all examinations and maintenance events carry out a visual check of the bogie frame for any signs of fracturing in the relevant areas. If any bogie frames are found to exhibit fractures, the wagon shall be red carded pending removal of the bogie, which shall then be quarantined.
