**TEST PROCEDURE FOR THE UT / MPI OF THE GPS  
BOGIE FRAMES.**

Issue 3	Date 28/08/2003	Revision A
<b>Purpose :-</b> To specify the test procedure that is to be utilised for the inspection of the GPS bogies frames for cracking.		
<b>Scope :-</b> Applies to all GPS 20 bogies

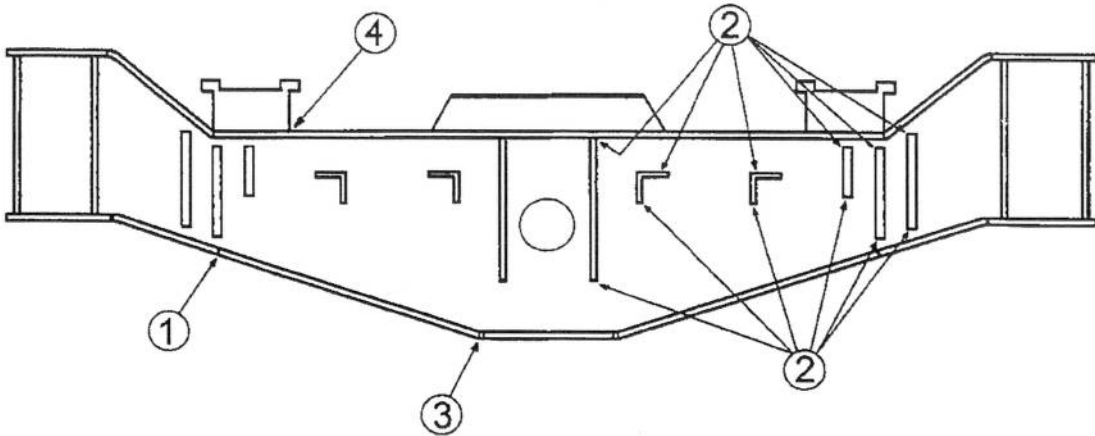
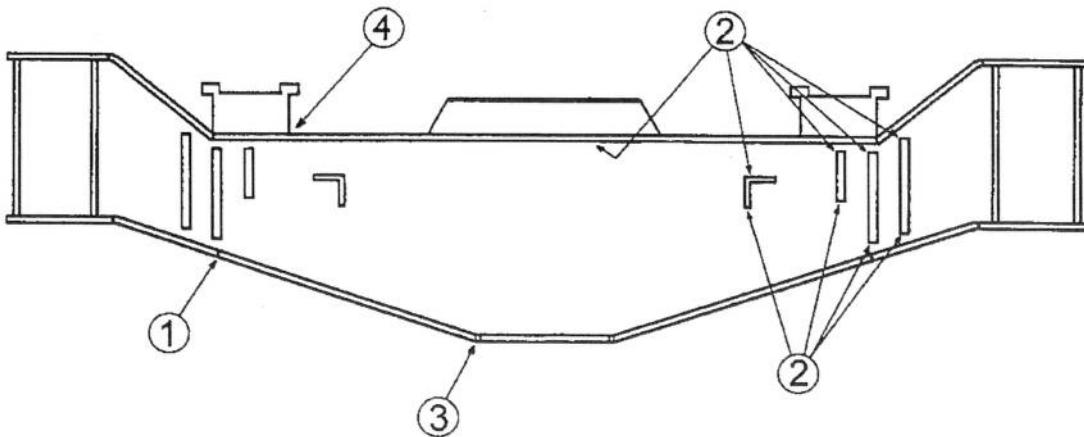
**Part 3 Inspection Record Sheets (Figure 10 Tread Brakes)**

VEHICLE NUMBER	BOGIE NUMBER
INSPECTION AREA	
1. CROSS WELDS IN BOTTOM PLATE	3. BOLSTER SIDE PLATE.
2. BOLSTER SIDE PLATES AT TOP & BOTTOM EDGES OF ALL BRAKE BRACKETS	4. WELD BETWEEN THE BOTTOM OF THE SIDE BEARERS & BOLSTER.
BOLSTER SIDE 1	
MARK UP ANY REJECTED LOCATION	
BOGIE FAILED / PASSED INSPECTION	
SIGNATURE	DATE
<p>MARK UP ANY REJECTED LOCATION</p>

<p>The diagram shows a side view of a bogie frame. Inspection point 1 is at the bottom left corner. Point 2 is at the top right corner, with multiple arrows pointing to different welds. Point 3 is at the bottom center. Point 4 is at the top left corner, pointing to a bracket.</p>	
BOLSTER SIDE 2	
MARK UP ANY REJECTED LOCATION	
BOGIE FAILED / PASSED INSPECTION	
SIGNATURE	DATE
<p>MARK UP ANY REJECTED LOCATION</p>

<p>The diagram shows a side view of a bogie frame, similar to Side 1. Inspection point 1 is at the bottom left corner. Point 2 is at the top right corner, with multiple arrows pointing to different welds. Point 3 is at the bottom center. Point 4 is at the top left corner, pointing to a bracket.</p>

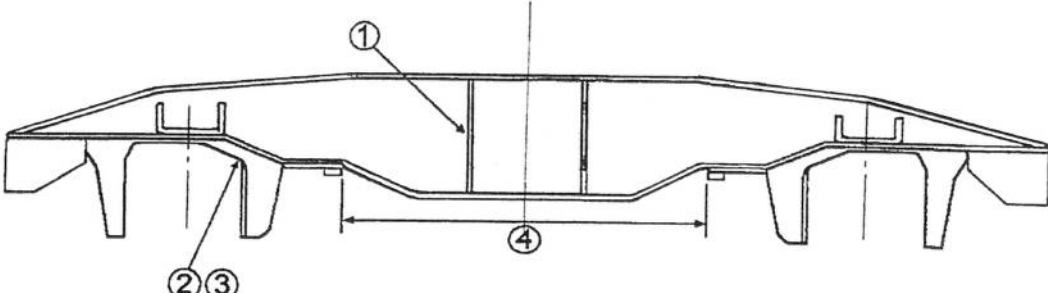
**Part 3 Inspection Record Sheets (Figure I3 Disc Brakes)**

VEHICLE NUMBER	BOGIE NUMBER
INSPECTION AREA	
1. VERTICAL WELDS AT CLOSEURE PLATE	3. WELD AT HORN GUIDE FACE PLATE.
2. HORN GUIDE SIDEPLATES	4. BOTTOM PLATE AND WELDS, SIDE FRAME BOTH SIDES.
SIDEFAME 1	MARK UP ANY REJECTED LOCATION
BOGIE FAILED / PASSED INSPECTION	
SIGNATURE	DATE
